# Crumlin Bridge Protected with Spray Applied Waterproofing

ELIMINATOR® and Bond Coat 3 provide high performance adhesion combined with durability

Project	Crumlin Bridge
Client	Caerphilly County Borough Council
Contractor	Dyer and Butler
Applicator	Metrail
GCP Solutions	ELIMINATOR® Bridge Deck Waterproofing System, METASET® concrete system, Bond Coat 3

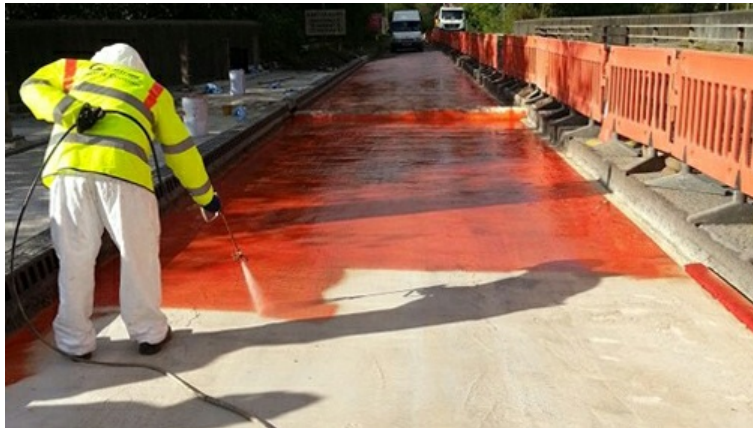
Prior to application, shot blasting and fine milling was carried out, with the METASET<sup>®</sup> concrete system being used to repair rough and damaged areas of the bridge deck in preparation to receive the waterproofing system. The deck was primed to seal the deck and promote excellent bond between the deck and the membrane.

The ELIMINATOR<sup>®</sup> membrane was then cold spray-applied and checked using a wet film gauge to confirm the required coverage and thickness had been achieved. Once the waterproofing membrane had been applied and left approximately 30 minutes to cure, it was electrically integrity tested (holiday detection test) to confirm that a defect-free, fully waterproof barrier had been achieved.

Bond Coat 3 was then spray-applied. The durability and unlimited open time of Bond Coat 3, allowed flexibility in the schedule and the following trades to proceed in compliance with the programme of works without unnecessary delays, saving time, money and further disruption. Due to the success of the project on the first 1150 metres of carriageway, the second phase of the project went ahead as planned completing the refurbishment of the Crumlin Bridge.
